2014 ANNUAL RESTORATION REPORT
FOR THE
EDGEWOOD COUNTY PARK RESTORATION PROJECT
GAS LINE 132 AT MILE POST 25.05
San Mateo County, California

January 2015

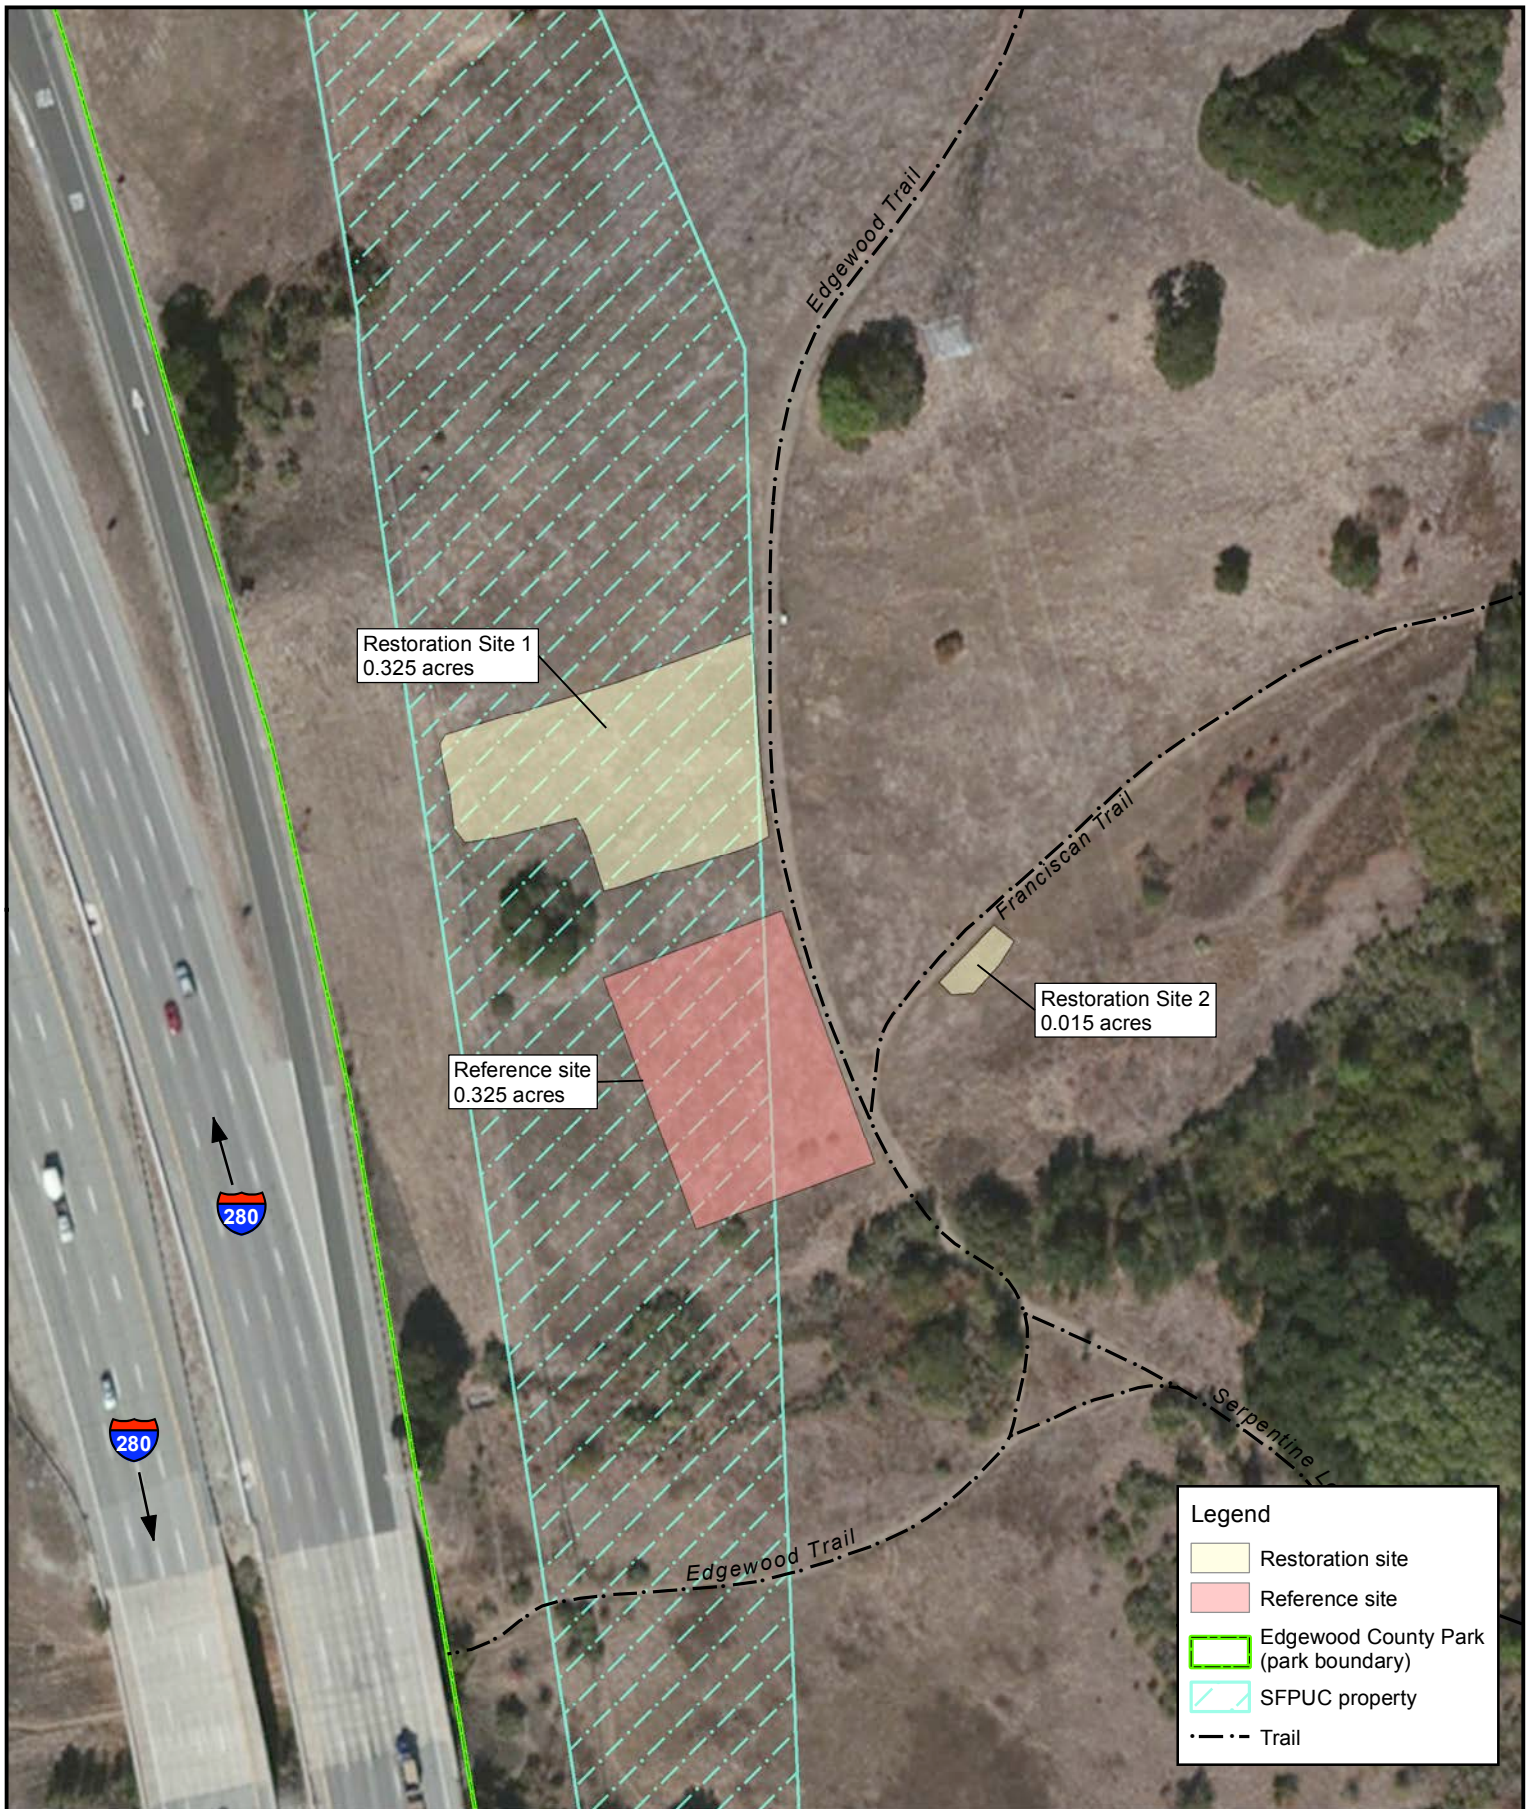
Figure 2
Restoration Sites
Edgewood County Park
Restoration and Monitoring
Project
San Mateo County, CA
December 2013

The restoration activities take place in Edgewood Park, within San Mateo County west of Redwood City. Figure 1 provides the regional location of the restoration sites, which are located in close proximity to each other. Restoration site 1 covers 0.325 acre and is situated between Edgewood Trail and State Route 280. Restoration site 2 covers 0.015 acre, and is immediately adjacent to the Franciscan Trail (Figure 2).

Restoration Site 1
0.325 acres

Reference site
0.325 acres

Restoration Site 2
0.015 acres

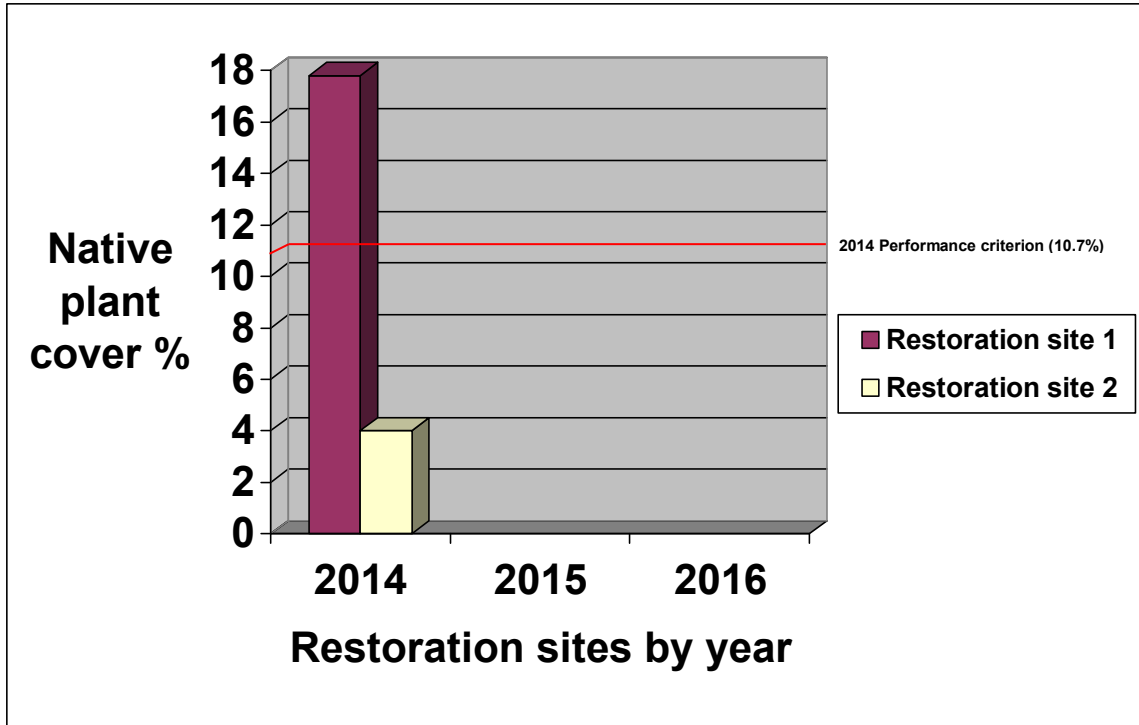
Figure 3 2014 Native Plant Cover in Restoration Sites

Vegetation data was collected from five transects to characterize and compare cover and species composition from two restoration sites and one control site. Within restoration site 1, the native cover ranged from 4 to 25.5 percent over the three transects, with an average of 17.8 percent. Non-native cover at restoration site 1 ranged from 32.5 to 64.5 percent over the three transects, with an average of 47.3 percent. Bare ground along the restoration site 1 transects ranged from 31 to 42 percent, and averaged 34.8 percent. At restoration site 2, 4 percent native cover, 10 percent non-native cover, and 86 percent bare ground were recorded along one transect. At the control site, 35.5 percent native cover, 35 percent non-native cover, and 29.5 percent bare ground were recorded on the final transect. No noxious weeds were observed within the restoration sites or the reference site. Monitoring data for each transect is summarized in Table 3-2.

The native cover first-year success criterion is 30 percent of the native cover observed on the reference site. Based on these monitoring results, restoration sites should achieve the threshold success criterion of 10.7 percent native cover. Restoration site 1 exceeds the threshold success criterion for this year. Restoration site 2 does not meet this threshold success criterion.

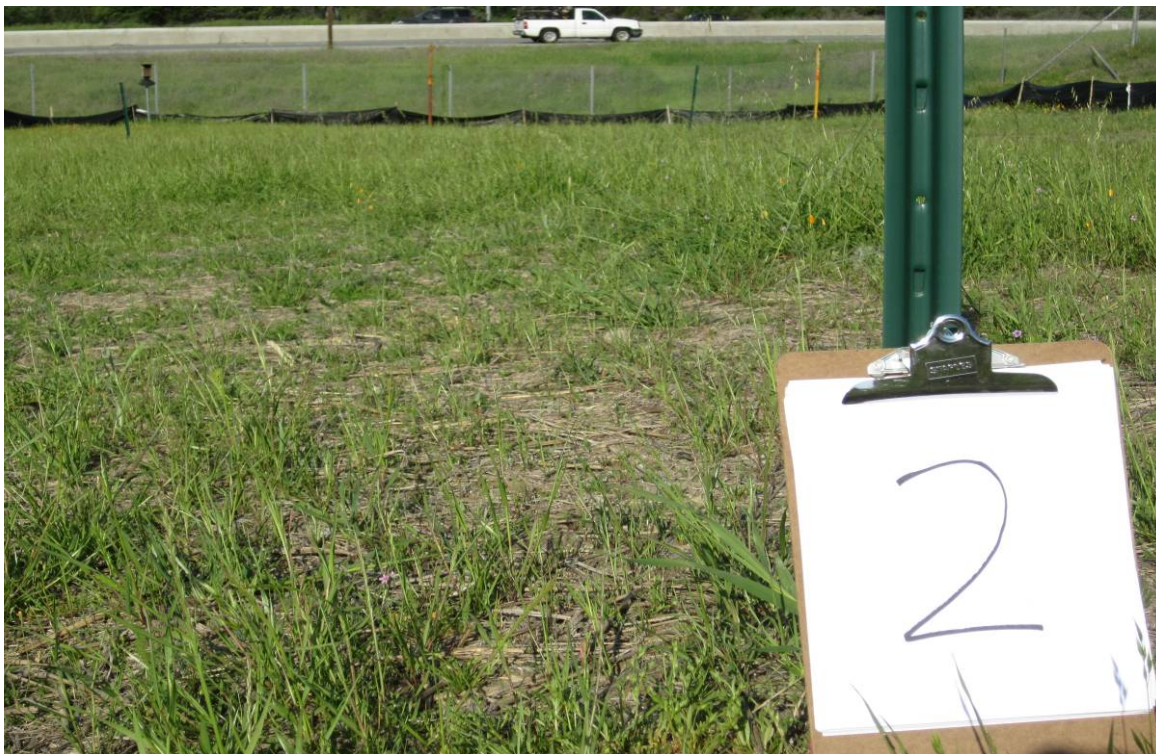
Transects	Native Association Cover (%)	Non-native Association Cover (%)	Bare Ground (%)	Noxious Weed Cover (%)
Restoration Site 1				
Transect 1	4	64.5	31.5	0
Transect 2	25.5	32.5	42	0
Transect 3	24	45	31	0
Restoration Site 2				
Transect 4	4	10	86	0
Reference Site				
Transect 5	35.5	35	29.5	0

Photo 2 **Transect 2 in restoration site 1**

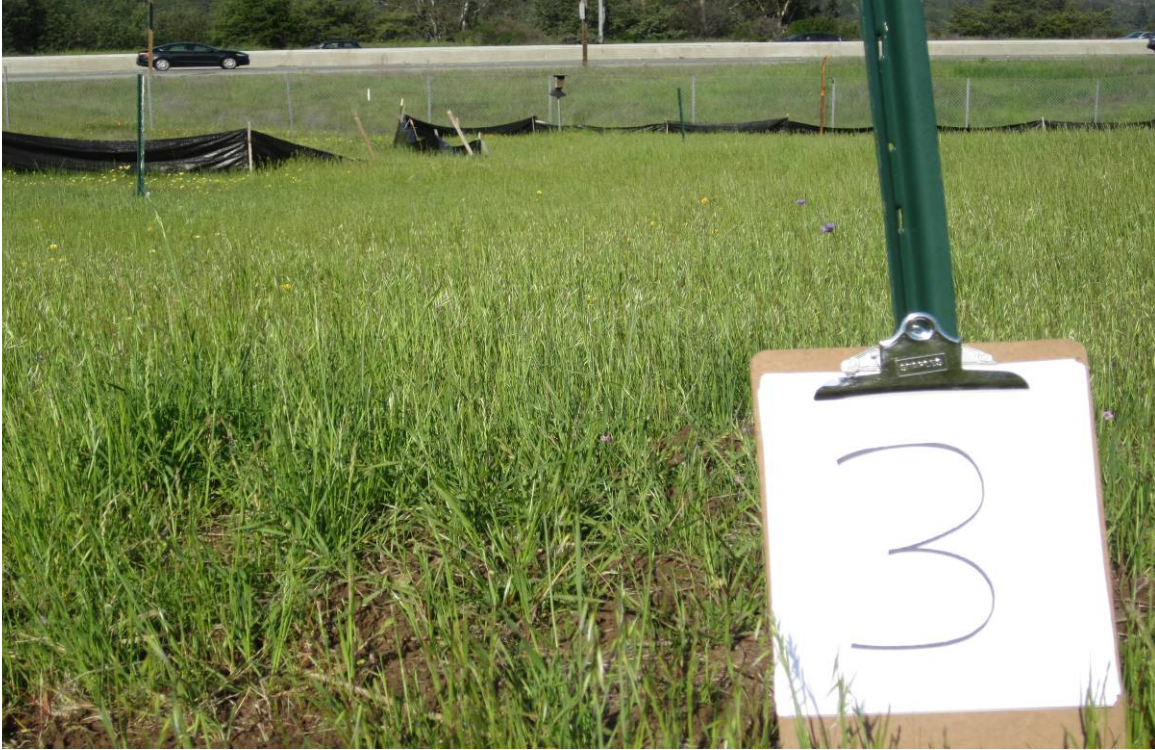
Photo 3 **Transect 3 in restoration site 1**

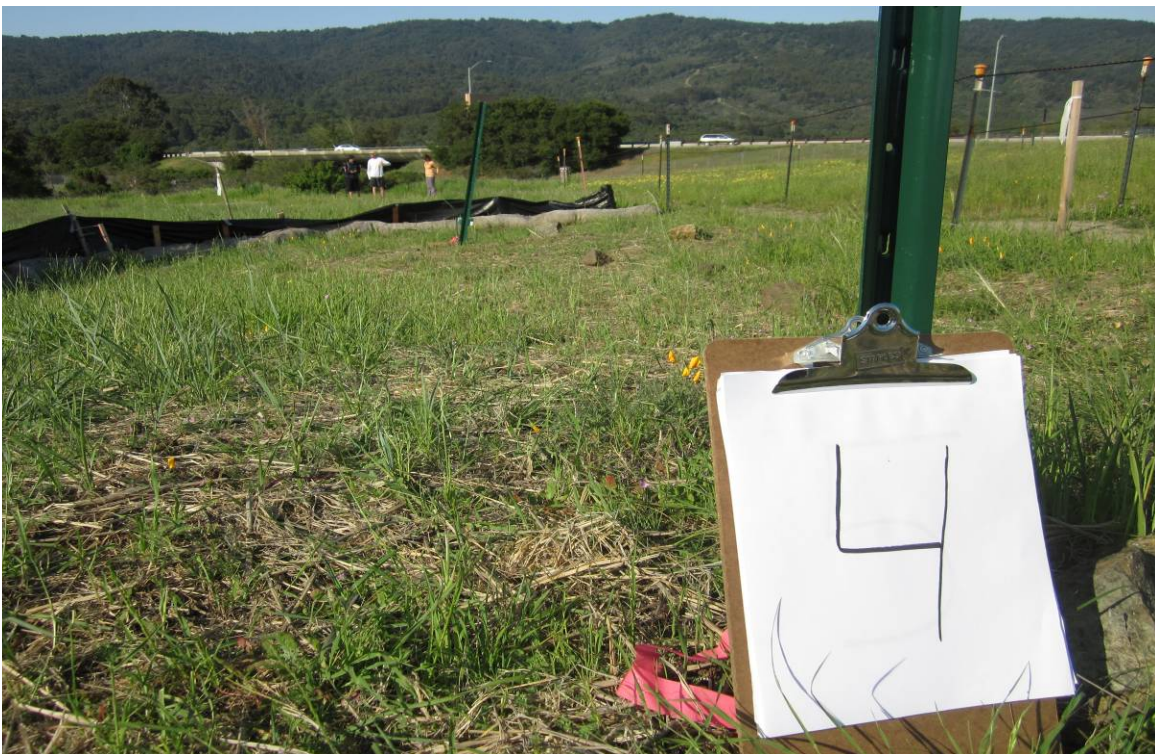
Photo 4 **Transect 4 in restoration site 2**

On November 24, 2014, Nomad Ecology Botanist Erin McDermott and Biologist Annemarie Abbondanzo seeded restoration site 2 and portions of restoration site 1 with 14.3 pounds of supplemental native plant seed purchased from Hedgerow Farms in Winters and Pacific Coast Seed in Livermore. Seed sources included genotypes from Crystal Springs Reservoir in San Mateo County. The seed mix included blue wildrye grass, foothill needle grass (*Stipa lepidota*), purple needle grass, and yarrow. The biologists broadcast the seed by hand throughout restoration site 2 and portions of restoration site 1, pressed seeds into the ground, and covered restoration site 2 with 600 pounds per acre of weed-free rice straw mulch.

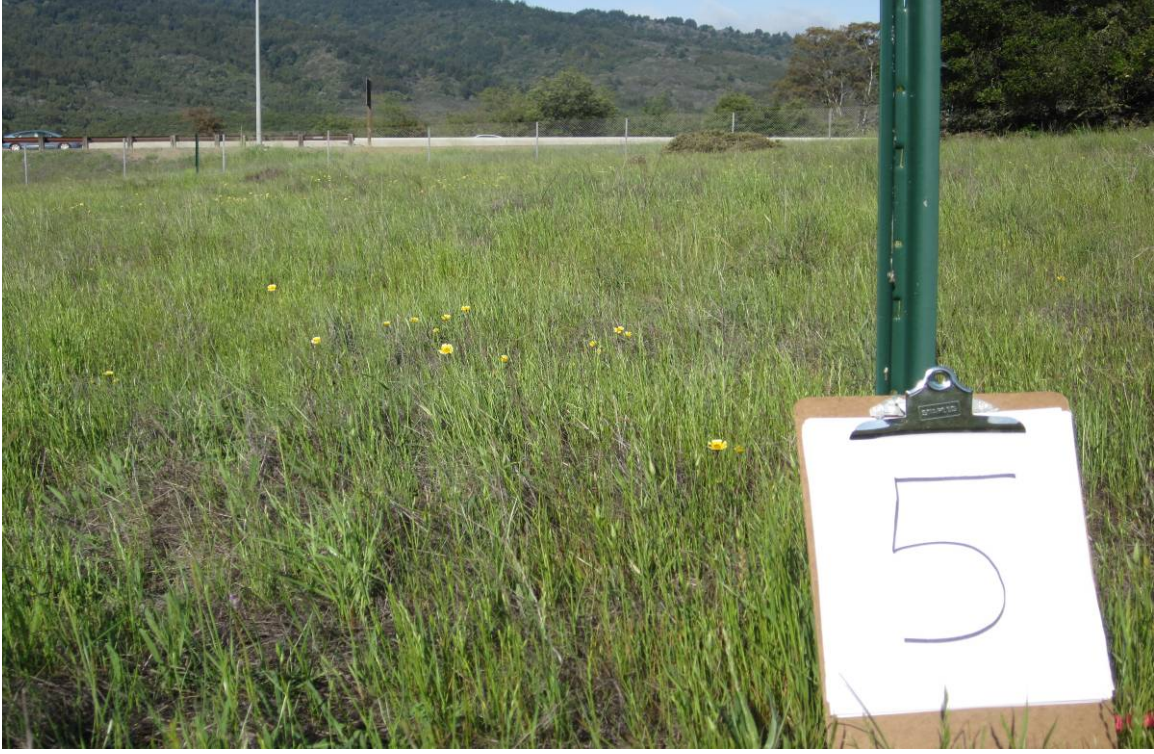
Photo 5 **Transect 5 in the reference site**
